Olympic Challenge

Scanning plays a critical role in the evolving design and construction of the Olympic Stadium in London.

Scanning London's

Olympic Stadium

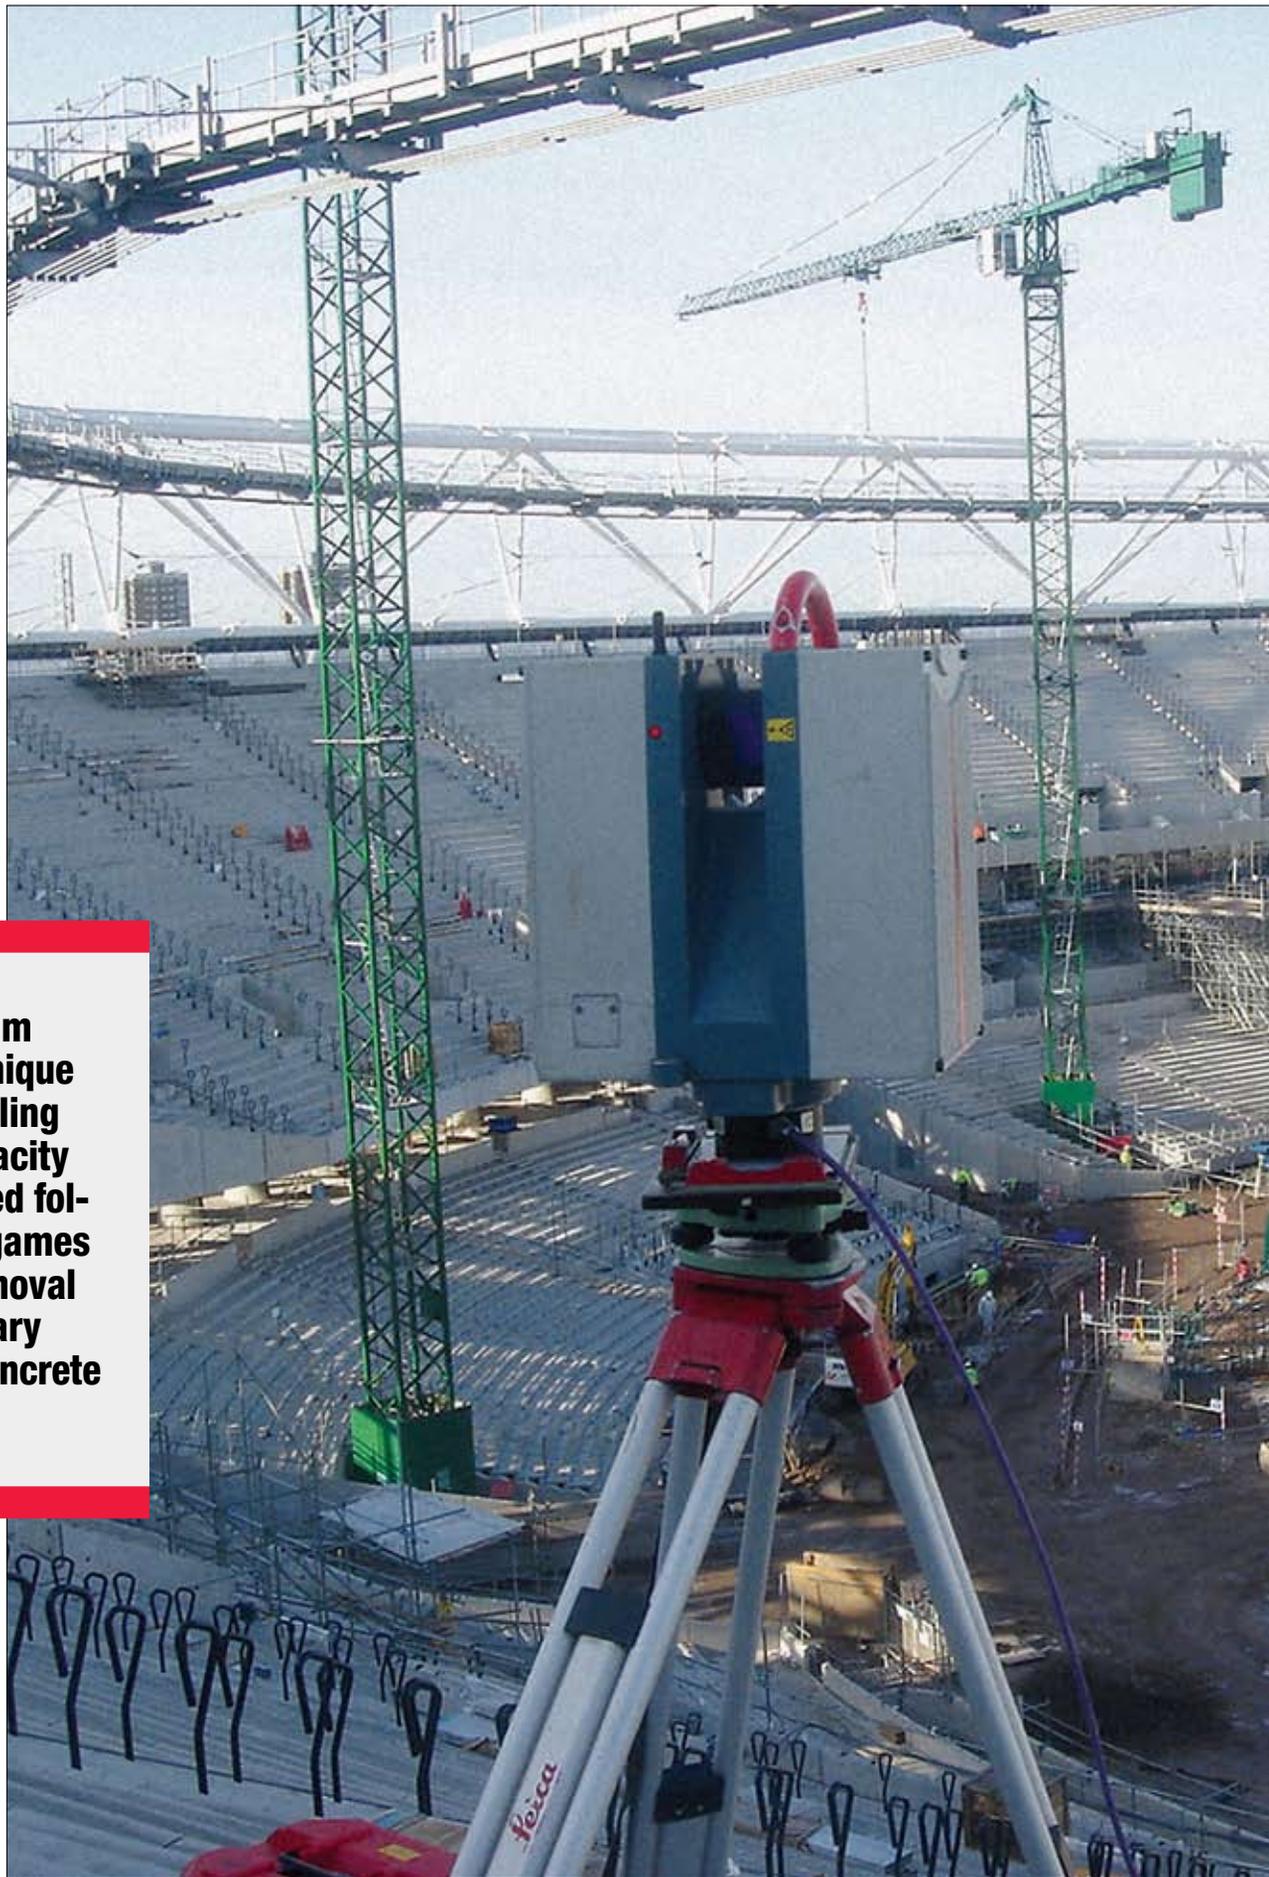
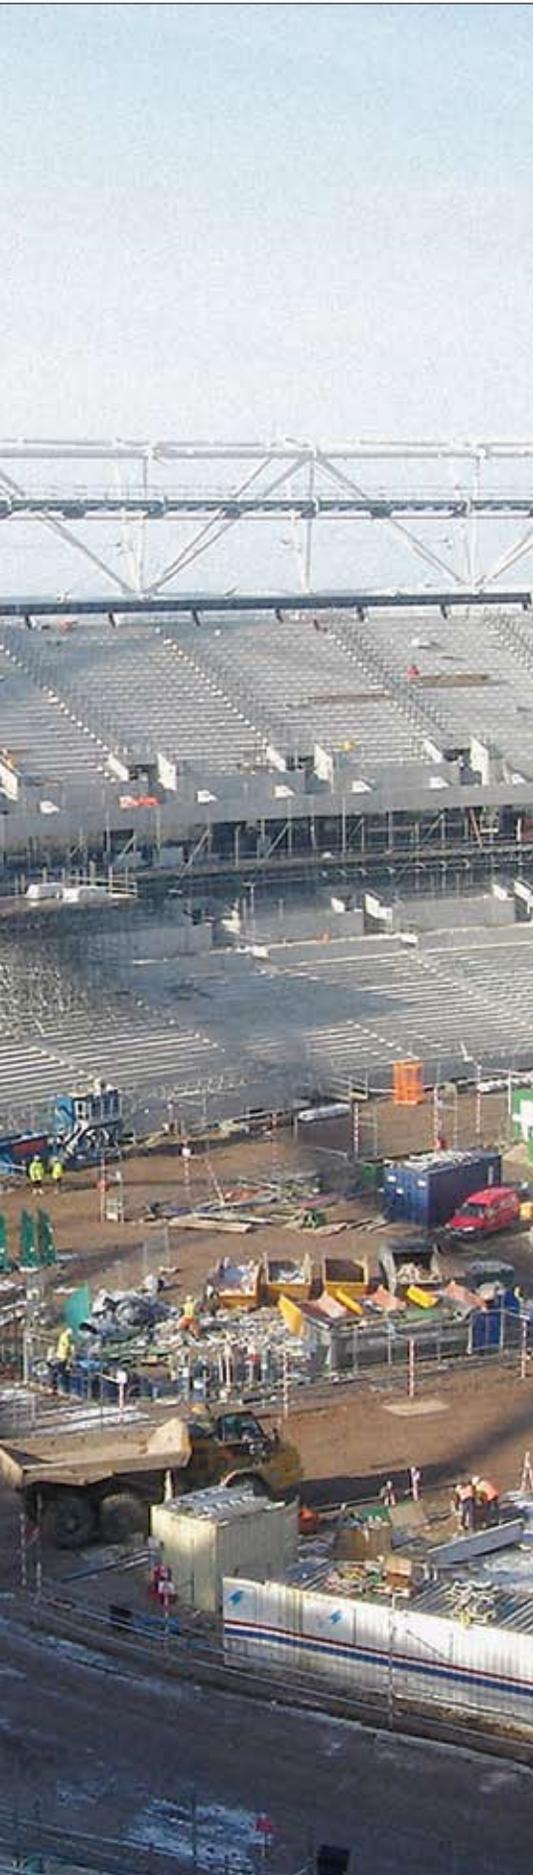
The upper tier terrace and roof-supporting structure are constructed from pre-fabricated compression truss- and roof-column connections with cables supporting a roof structure of PVC fabric.

Team Stadium created a unique design enabling seating capacity to be reduced following the games with the removal of a temporary steel and concrete upper tier.

The upper section supporting the stadium's partial "roof" is constructed from pre-fabricated compression truss and roof-column connections with cables supporting a roof structure of PVC fabric. Triangular lighting support towers stand on top of the roof structure.

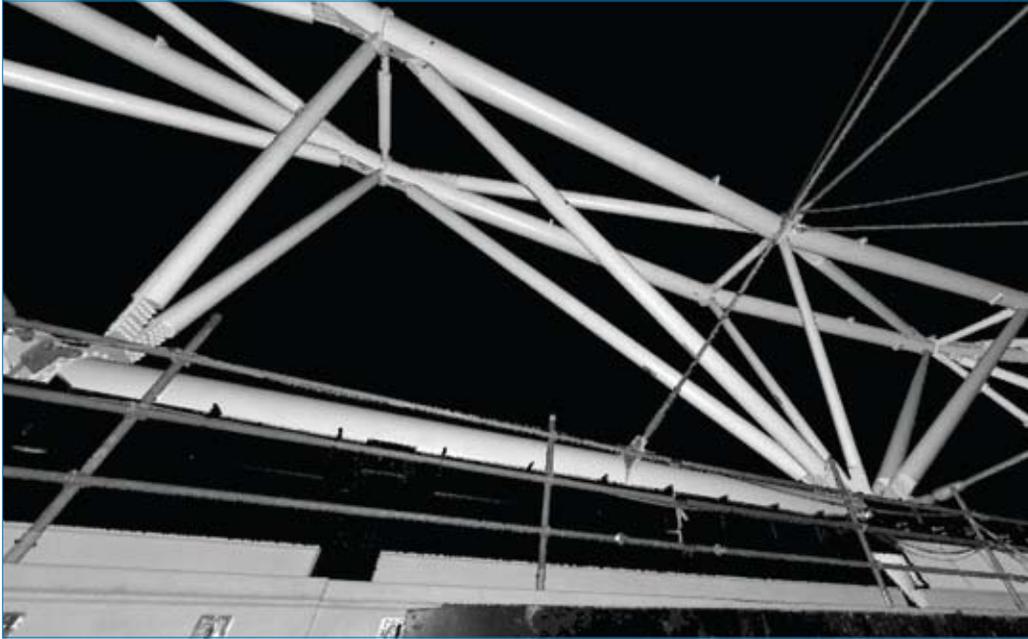
This high-resolution scan of the roof-supporting structure was taken using a high-speed phase-based 3D laser scanner. The point cloud is displayed in grey-scale intensity mapping, with locating holes and individual rivets visible.

The locating hole positions were clearly visible in the high point density scans. Once again, an area of the point cloud was worked on in a new model space, and the holes were located with the aid of parts templates, which the team had constructed to aid the fitting process.
